**ENVIRONMENTAL IMPACT STATEMENT
FOR
THE PRESERVE AT WEST BRANCH**

**COMPLETED: 7/22/21
REVISION: N/A**

PREPARED BY:
Pulte Home Company, LLC
1900 E Golf Road
Suite 300
Schaumburg, IL 60173

**WETLAND
DELINEATION AND
ASSESSMENT REPORT**

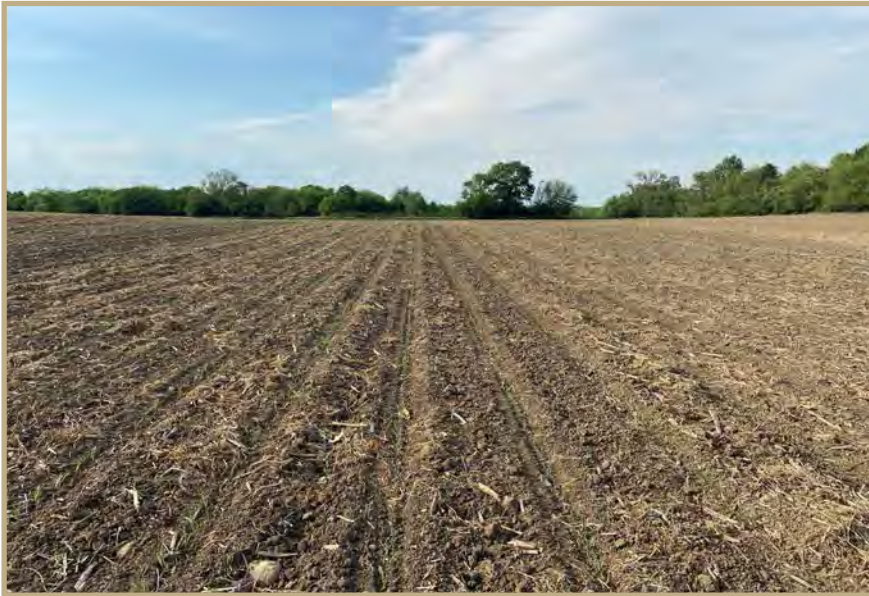
PHOTO 1

Image of upland Area 4, near Data Point X01. Facing north.

- Data Point X01 fails to satisfy all three criteria; therefore Area 4 does not qualify as wetland.
- Data Point X03 fails to satisfy the vegetation and hydrology criteria; therefore Area 4 does not qualify as wetland.

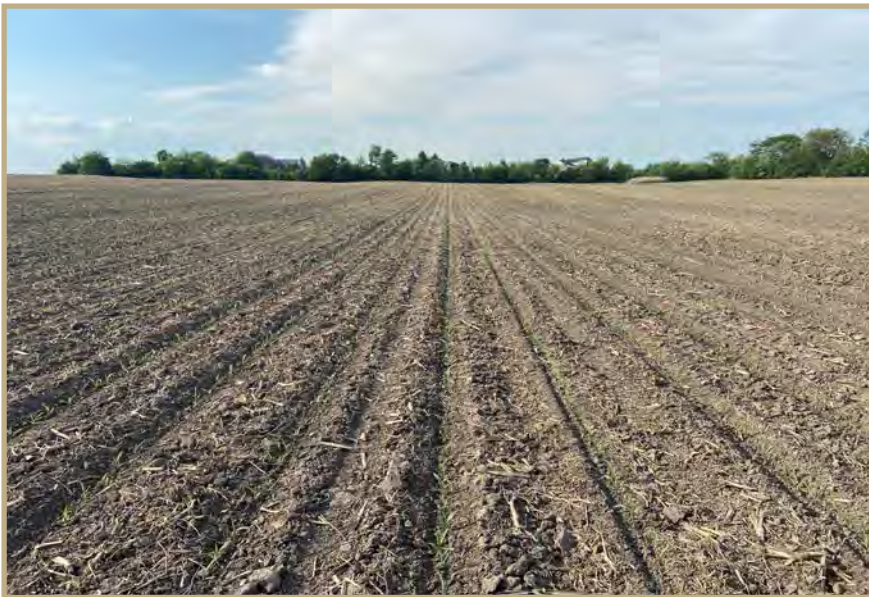
PHOTO 2

Image of upland area 4, near Data Point X03. Facing north.

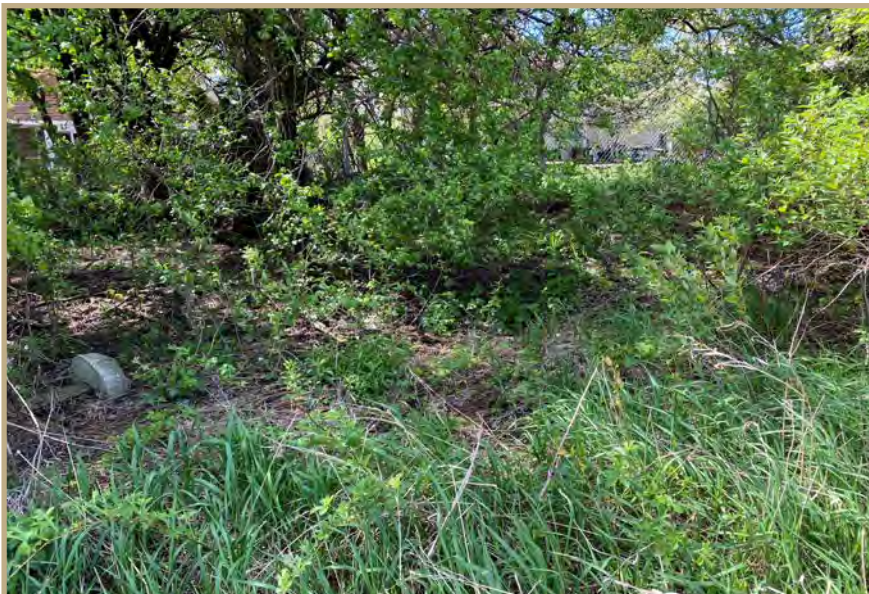
PHOTO 3

Image of upland Area 4, near Data Point X04. Facing south.

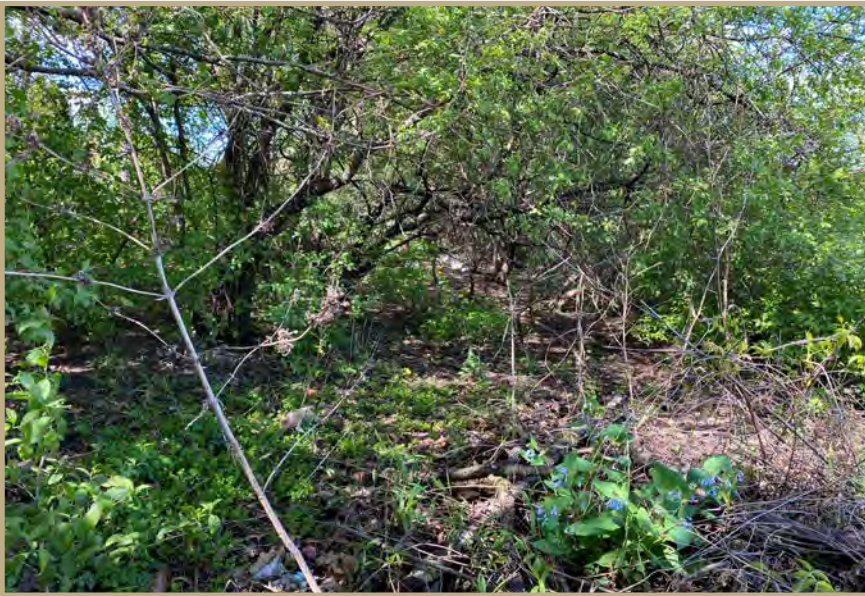
PHOTO 4

Image of upland Area 4, near Data Point X05. Facing southwest.

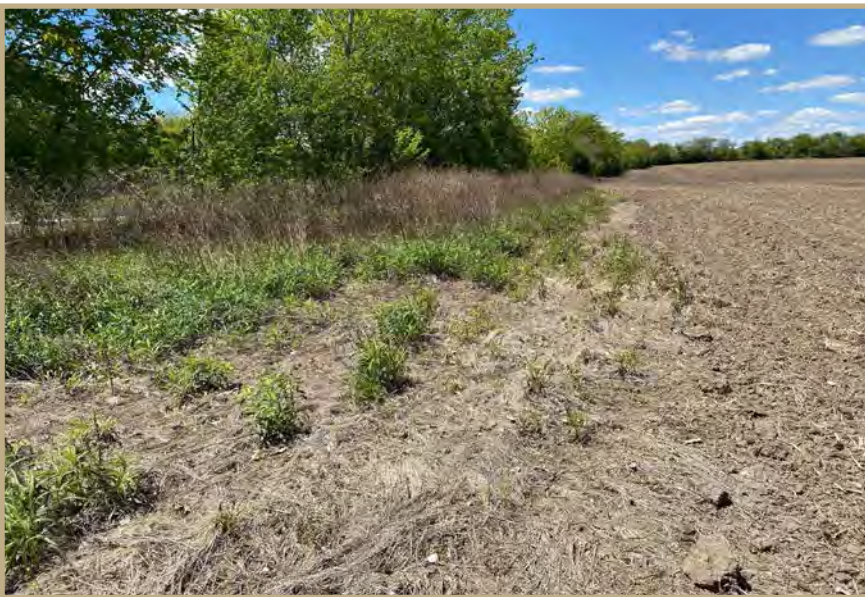
PHOTO 5

Image of wetland Area 1, near Data Point X06. Facing west.

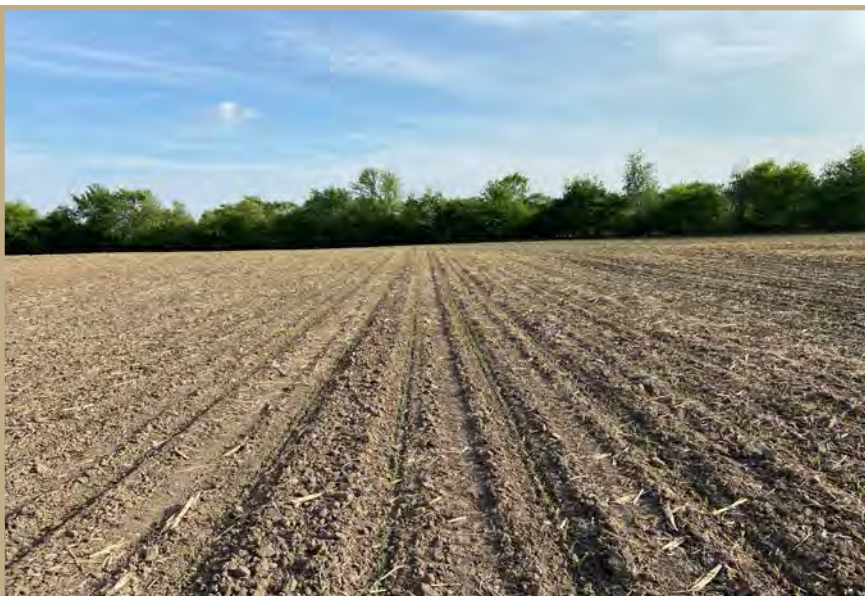
PHOTO 6

Image of upland Area 4, near Data Point X07. Facing south.

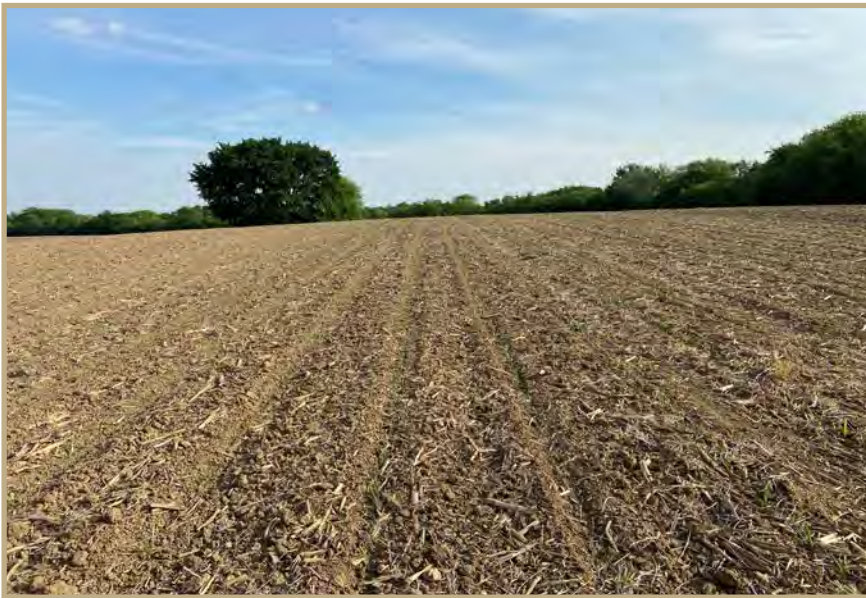
PHOTO 7

Image of upland Area 4, near Data Point X08. Facing south.

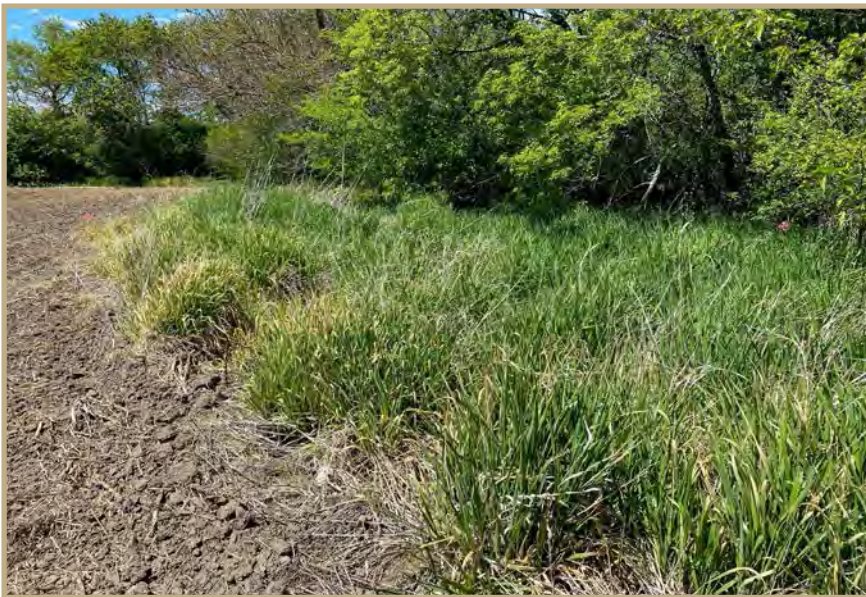
PHOTO 8

Image of wetland Area 2, near Data Point X09. Facing west.

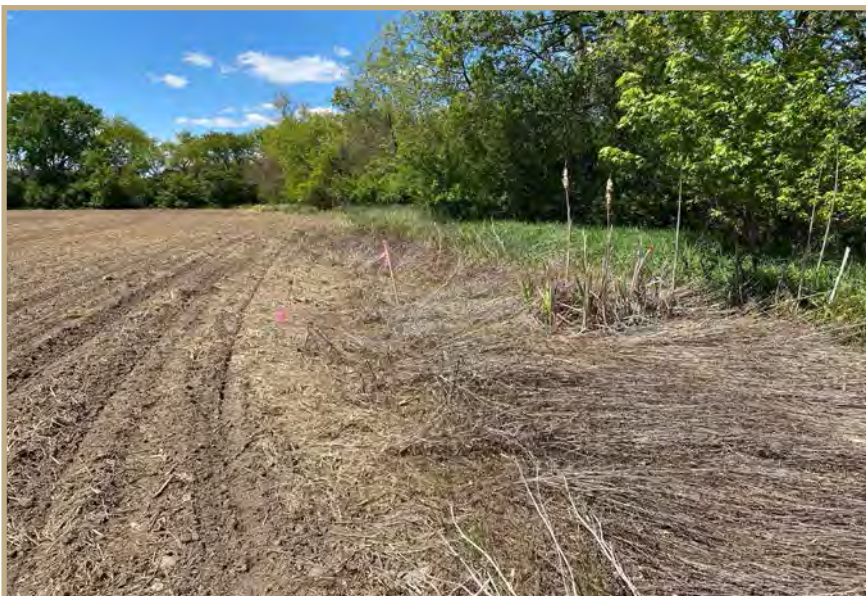
PHOTO 9

Image of wetland Area 3, near Data Point X10. Facing west.

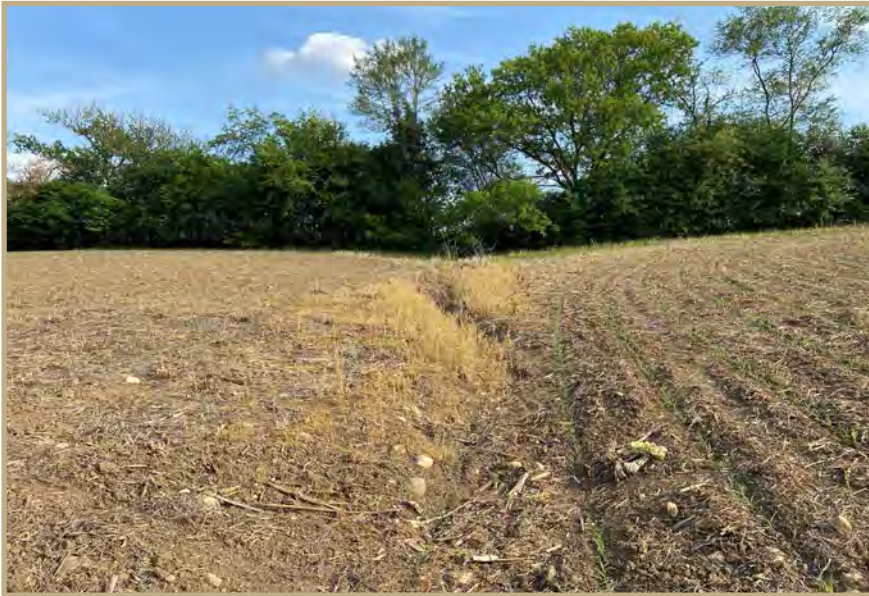
PHOTO 10

Image of upland Area 4, near Data Point X11. Facing north.

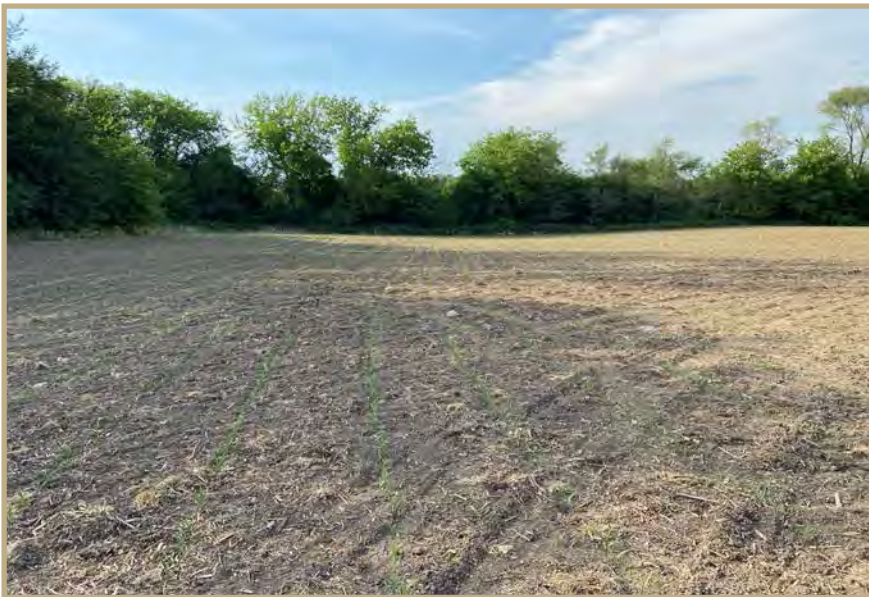
PHOTO 11

Image of upland Area 4, near Data Point X12. Facing north.
